COMPREHENSIVE LAKE MANAGEMENT PLAN

Long Lake and Bass Lake

Lincoln County, Wisconsin

Long and Bass Lake Association, Inc.

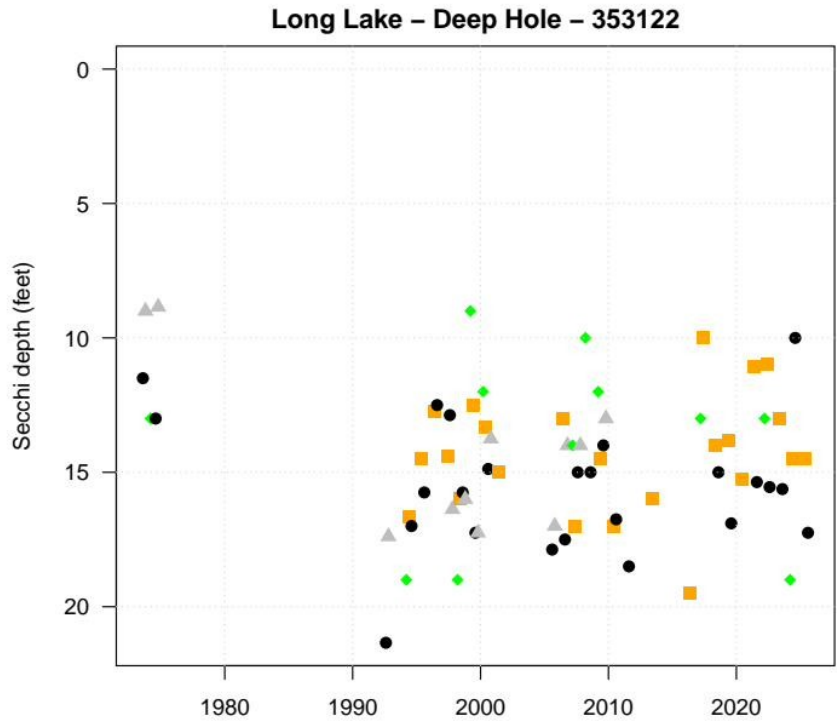
Figure 4.2a: Long Lake Water Clarity Trends (1973-2025)

No statistically significant trends detected. Water clarity has remained stable over 52 years of monitoring.

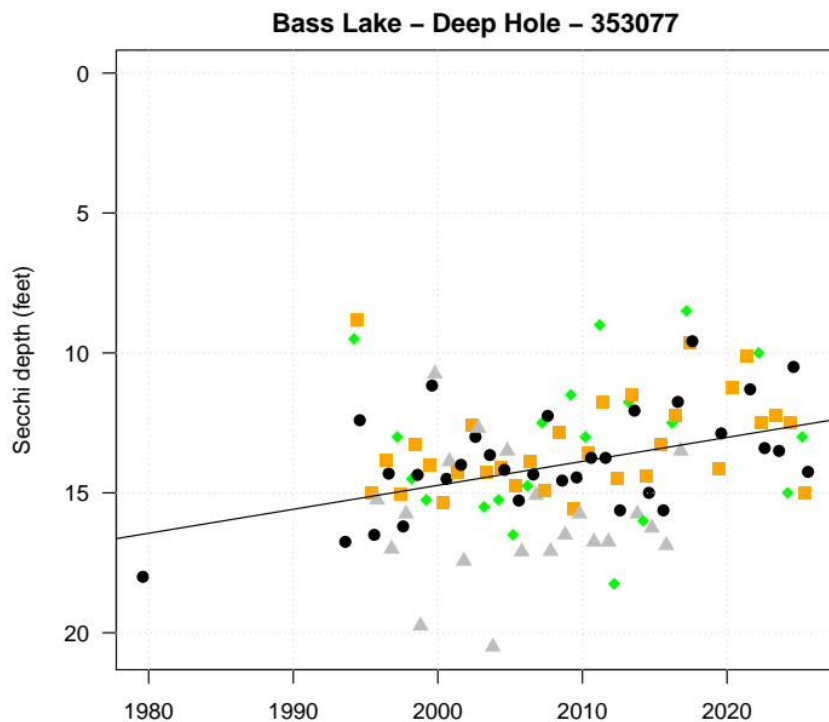
Late summer shows statistically significant declining trend ($p=0.010$). Solid trend line indicates significant change.

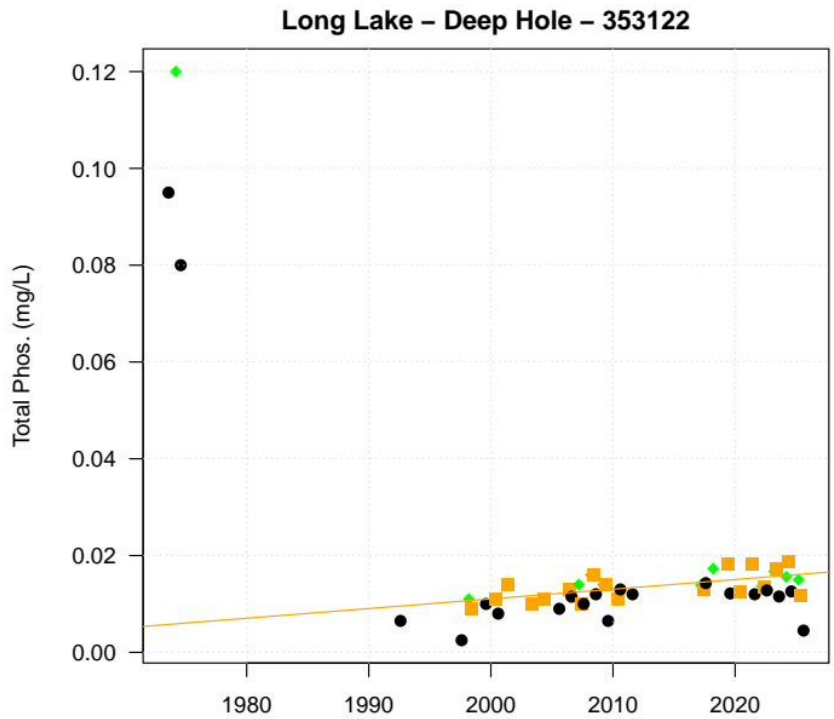
Early summer shows increasing trend ($p=0.013$). Late summer remains relatively stable.

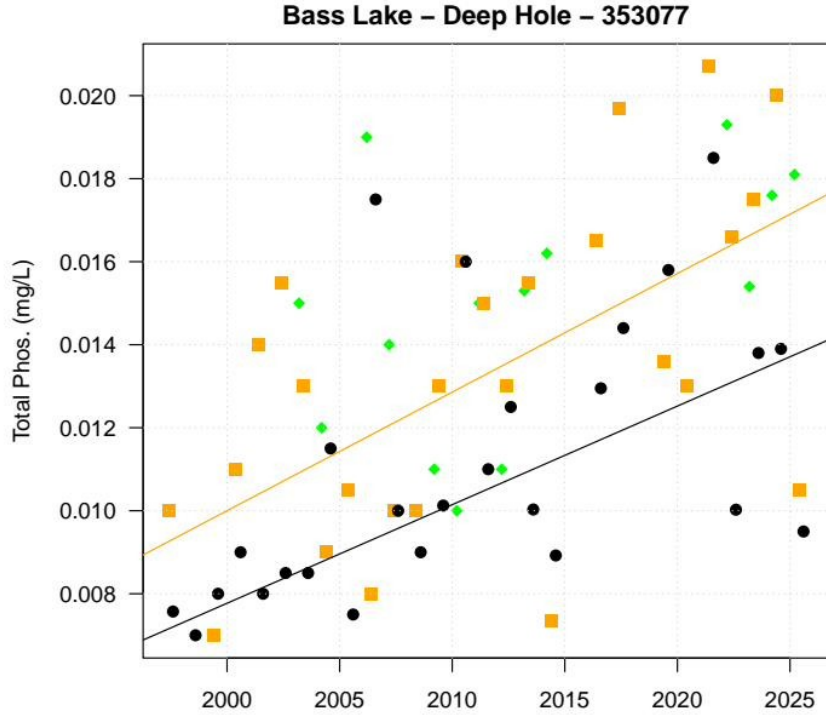
Both early summer ($p=0.003$) and late summer ($p=0.0005$) show statistically significant increasing trends.

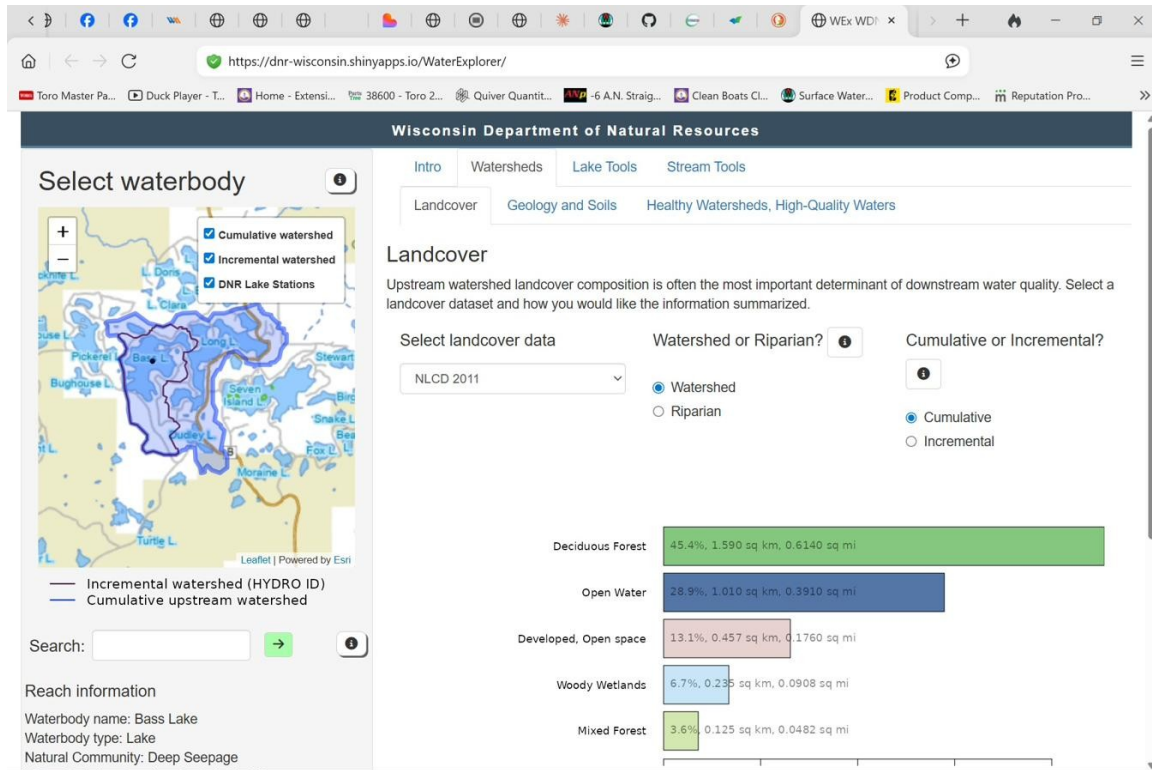
Figure 8.1: Wisconsin Water Explorer watershed view showing land cover composition.
